# Venice From Above: Preserving Venetian Bell Towers

## VENICE FROM ABOVE:

### An Effort to Preserve Venice's Bell Towers

An Interactive Qualifying Project Report Submitted to the faculty of

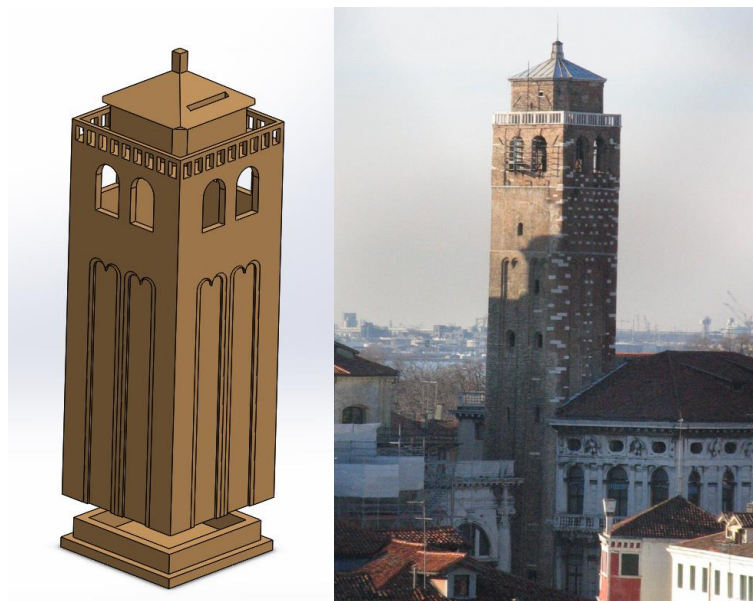
**Figure VII:** 3D printed model of San Geremia and picture of San Geremia bell tower

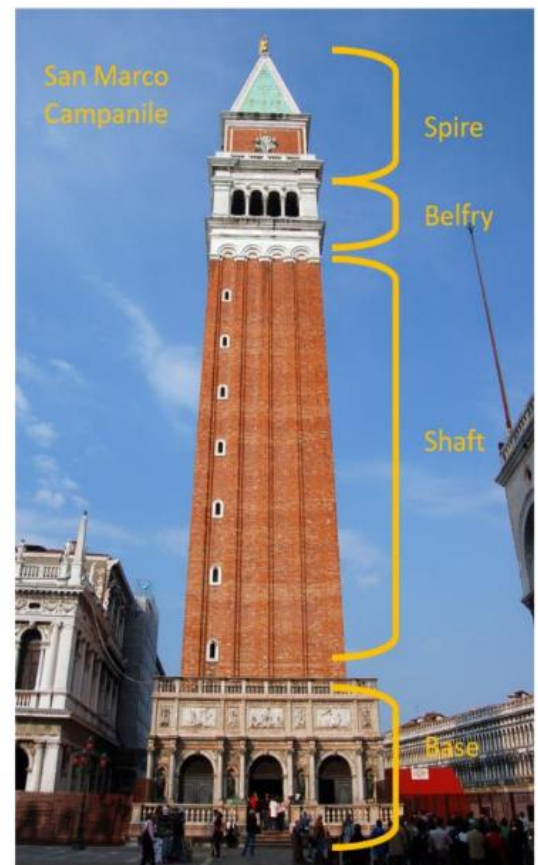
**Figure 2.7:** Major Parts of the bell tower at San Marco (Huntley et al., 2016)

The Standard tower is the more common of the two styles in Venice by far. There are four main parts to the tower's anatomy: the base, shaft, belfry, and spire, each of which contributes to the overall style and integrity of the tower. Figure 2.7 shows the common layout of a Standard tower. The base is the foundation of the tower and bears the full weight of the tower. It is typically made of thicker, denser stone than that of the top of the towers. The stone is also usually less porous than the rest of the tower, so as to slow erosion from water and salt. The base may also contain tensioning supports to tether the tower down and provide stability (Huntley et. al, 2016).

The belfry is the part of the tower that encloses the bell chamber. This portion could be made of wood or a variety of different stones or clays. The inside contains the bell frame, typically made of either wood or steel from which the bells swing. The outsides of belfries can be decorated with carvings, statues, or other decorative elements. The belfry may be completely open or closed with windows or louvres. Most belfries are closed to protect against weather damage or prevent birds from entering and nesting. There may also be balconies or walkways around the perimeter, allowing people to walk around or look out of the tower (Huntley et. al, 2016).

Finally, there is the spire, acting as the roof of the tower. Depending on the size and height of the spire it could contain an attic of sorts above the bell chamber; access is provided by a ladder or small staircase. Common spire designs include a tapered pyramid and a dome. A finial or decorative ornament may adorn the top, serving the function of a weathervane, lightning rod or cosmetic feature (Huntley et. al, 2016).

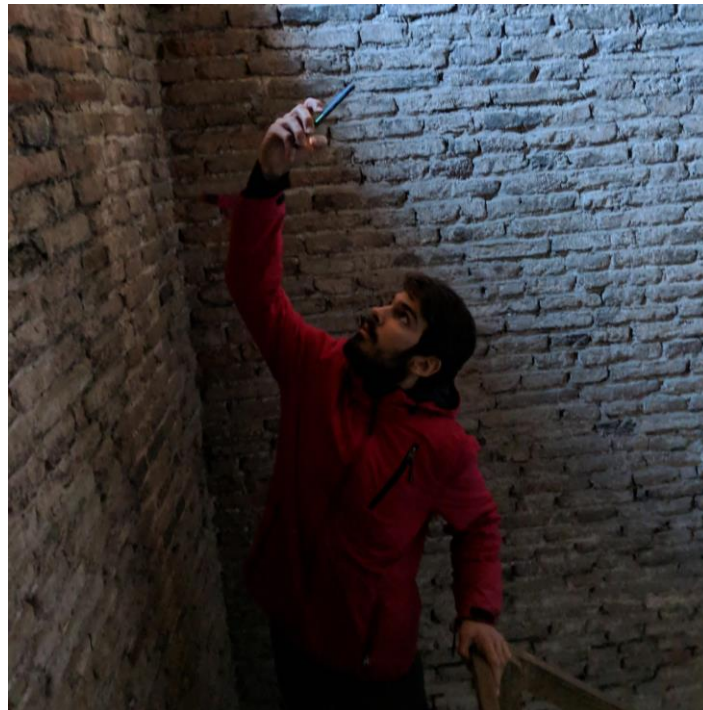
**Figure 3.4:** Interior Assessment of Tower

The data on the interior of the towers was focused on the decoration and dimensions of the tower interior, the dimensions and condition of the stairs, and the type and condition of the bell frame. We collected 37 different data fields based off of the data collected by the 2016 team. These data fields are listed in Table A.2 in Appendix A. The interior was divided by the landings

in the tower, including the ground and belfry. All counting and qualitative measurements were made by direct inspection of the object or room in question. Subjective measurements were measured on a scale of 1-5, where 1 represents very poor condition and 5 represents very good condition. Condition measurements were documented with photographs. Size measurements were made using a tape measure and laser measure. Pictures of the internal features of the tower and its views were taken in the collection.

For quantitative data we collected the measurements of the landings traveling up the tower. Landings were defined as large, open areas that could contain more than one person at a time and were not simply larger steps in the staircases. Dimensions of landings, stairs, and windows were recorded using the laser measure or tape measure from wall to wall or stair to stair. To measure the wall thickness we required a window without glass or a screen so that we could get the tape measure out to the edge. We then measured from the inside of the tower wall to the surface outside the window to determine the wall thickness.

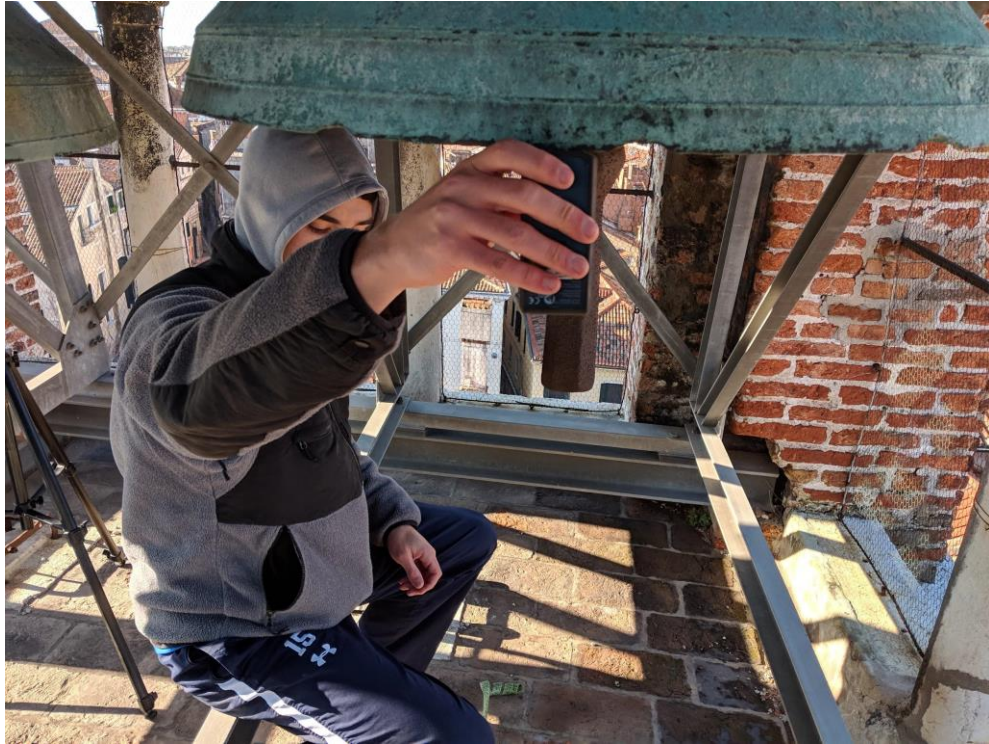
**Figure 3.5:** Manual Swinging of the Bell Clapper

The first type of data we collected was about the ringing of the bells. Using an audio spectrum analysis app on a smartphone, we measured the ringing frequency of the main hum, then used the frequency to calculate the musical note that the bell played. We then recorded the sound of each bell by manually swinging the clapper. If the bells still were rung normally, we also recorded the bell chorus.

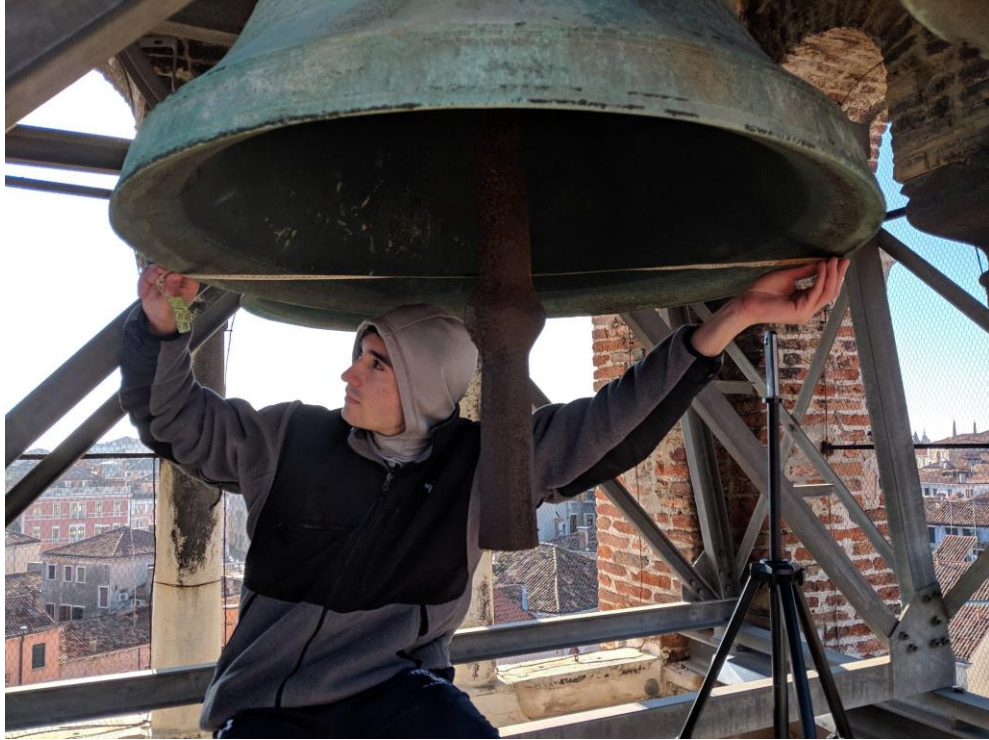
**Figure 3.6:** Measuring Bell Diameter

If the information was available, we also recorded the actual times the bells rang on each day of the week. Next, we collected data on the artistic design of the bell. This consisted of describing the engravings on each side of the crown, body, and lip of the bell and taking pictures of all accessible sides of the bell. After describing the engravings, we recorded the inscriptions on each side of the crown, body, and lip of the bell. If the inscriptions were unreadable, we cleaned the bells with water and brushes, then used chalk to make the letters stand out. Whenever possible, we used the inscriptions to record the date that the bell was made and the foundry that cast it. We then recorded the length and condition of the clapper as well as the way it was attached to the bell. We continued by recording if the bell was still rung and the method with which it was rung. Finally, we recorded the physical properties of the bells. Diameter, internal height, and height from the ground were recorded using a tape or laser measure, and calipers were used to measure the bell thickness. The calipers were placed at the intersection of the body and the lip of the bell, which is its thickest point, and were tightened as much as possible without scratching the surface of the bell.

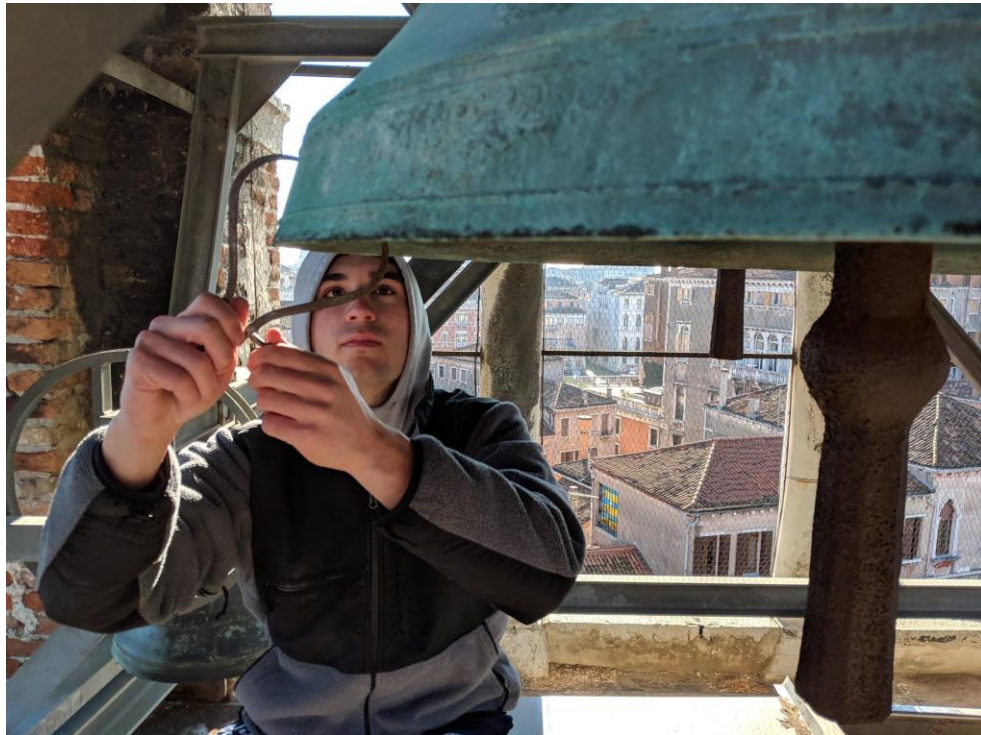
**Figure 3.7:** Measuring Bell Thickness

The distance between the two claws was then measured with a tape measure. Next, we recorded which sides of the bell were cracked, if any. Finally, we recorded the cleanliness, discoloration, amount of chips, decoration legibility, and overall condition on a scale of 0-4, where 0 is very good and 4 is very poor, as past projects did.

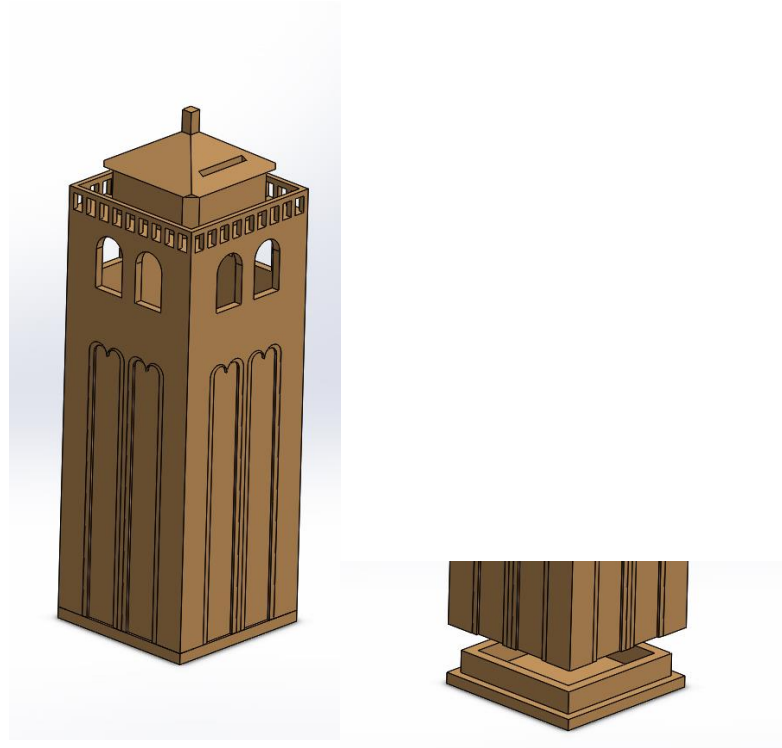
**Figure 4.22:** 3D Model of San Geremia with Bottom Opening

The 3D model of the San Geremia bell tower is a sample of a way that churches could try to draw attention to donation bins. The model (23cm x 7cm x 7cm) is hollow to hold coins, and there is a slot at the roof designed to accept the diameter and thickness of any Euro coin (Figure

4.22). We also modeled a bottom opening in order to both secure the coins collected and allow retrieval of coins from the tower once it has reached its capacity (Figure 4.22). While the VPC did not have a 3D printer by the end of our project, the files of the 3D model have been submitted so that the VPC or SerenDPT can print the model once the VPC acquires a 3D printer.

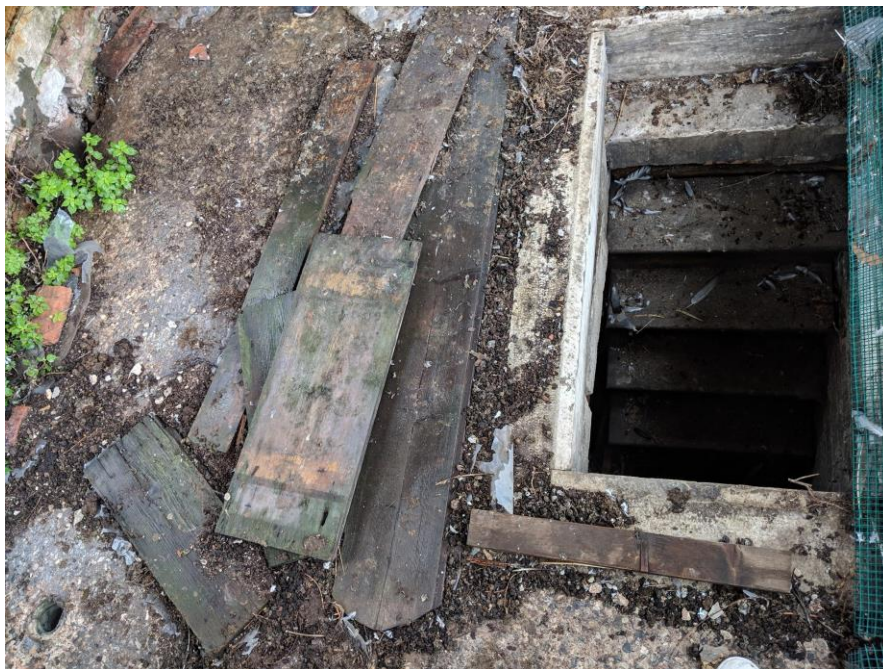
**Figure 5.1:** Unclean Conditions in Sant'Andrea Belfry

To help in the preservation of Sant'Andrea we suggest that there be a major cleanup of the tower. This was by far the worst tower in terms of cleanliness and should have not reached that condition. After the cleanup the bird nets would need to be replaced and any holes in the roof would need to be patched. The stairs and structure of the tower were very sound and are not in need of repair.

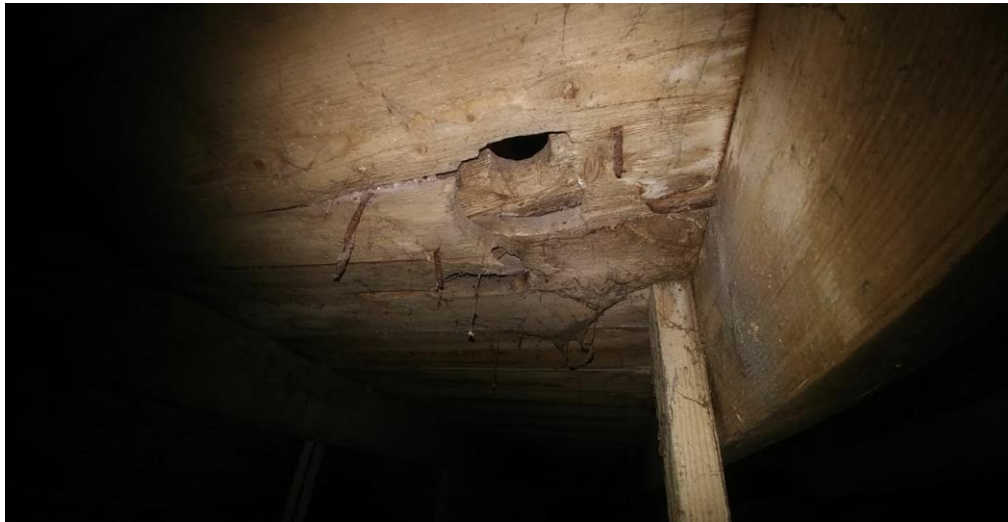
**Figure 5.2:** Hole in Top Landing of San Polo

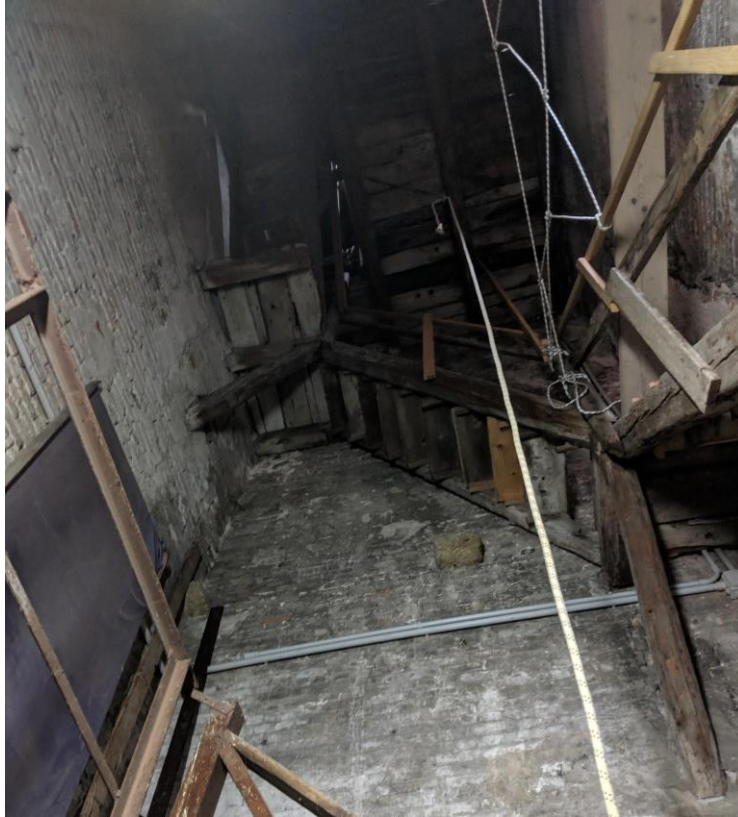
**Figure 5.3:** Staircase of Sant'Eufemia
